# Home Inspection Report

Address Redacted

Report Prepared By:  
James H. Duke

July 24, 2006

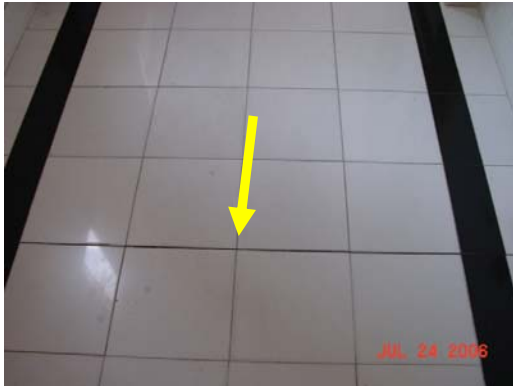
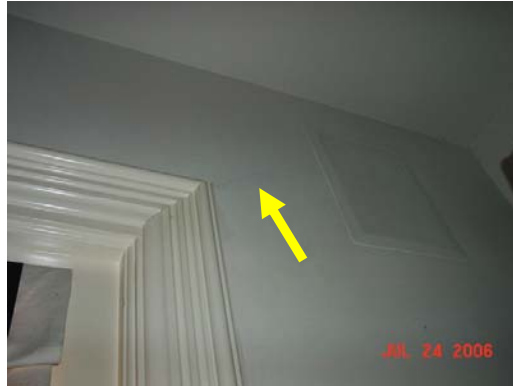
- A. There is evidence of foundation movement and framing movement across the home from east to west in the portion of the home just north of the garage. This movement might be related to the tree on the west side of the maid's quarters (southwest bedroom suite). Recommend further evaluation by a structural engineer for remedies as appropriate. See photos 1 for the tile separation in the hall, and photo 2 for the wall movement above the door to the patio in the exercise room.

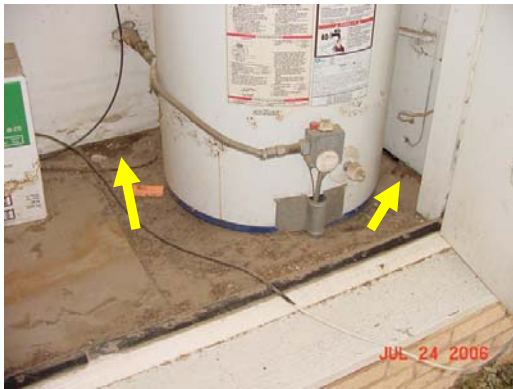
Photo #3

- B. There is the possibility for a mold issue inside the mechanical closet on the west side of the home. The floor in the mechanical closet is collapsing from moisture damage (a leaking water heater). Recommend destructive testing by a mold remediation company and remedy as appropriate. See photos 3 and 4 for damage.

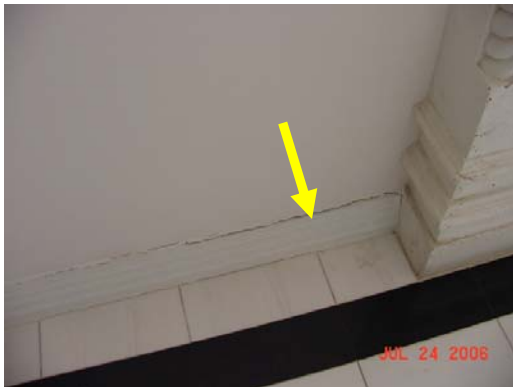
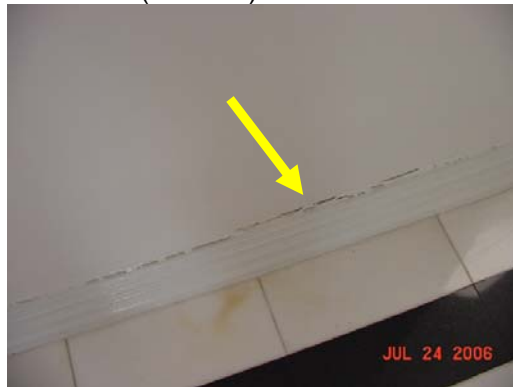
- G. There is evidence of moisture intrusion into the home on the west wall of the hall leading to the garage. Recommend destructive testing by a mold

remediation company and remedy as appropriate. See photos 5 and 6 for detail.

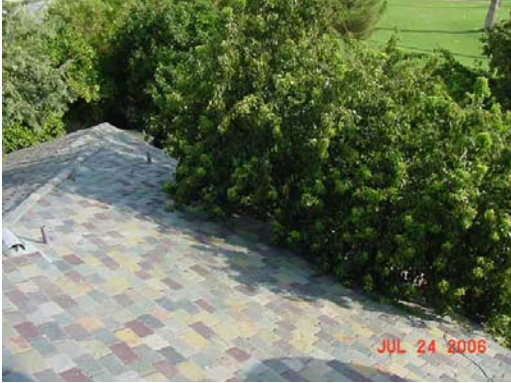
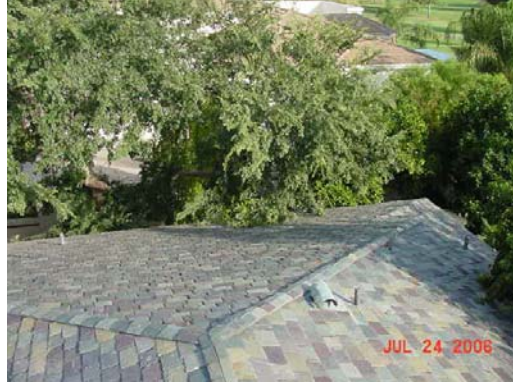
- A. There are trees in contact with the roof surface. Recommend pruning trees to avoid contact. See photos 7 and 8 for detail.
- B. There are cracks in the driveway just south of the garage. It is unknown if this is due to soil instability or defective concrete. Recommend evaluation and repair by a licensed concrete contractor. See photos 9 through 11 for detail.

Trees or branches overhang the house. This condition, if allowed to continue, could cause damage to either the roof covering or the siding on the home. Recommend trimming branches to provide at least a six-inch separation between home and tree branches.

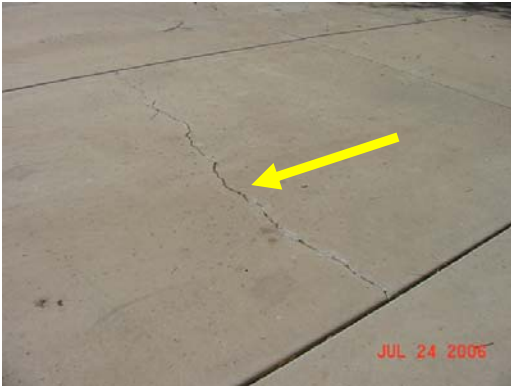
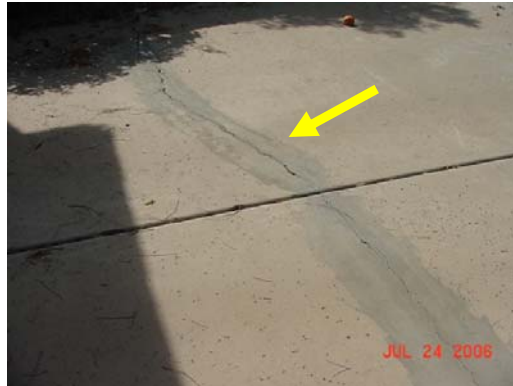
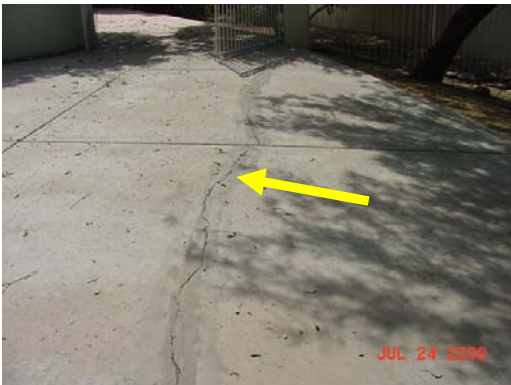
The driveways are concrete and show extensive cracking. The work may be subject to ongoing instability.

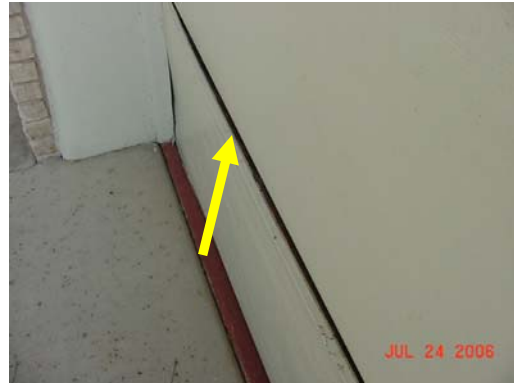
Photo #13

- A. There is no visible weep screed on the exterior of the home. The stucco and or the brick veneer is in contact with earth. Moisture damage in photos 4 and 5 might be the result of this condition. Recommend examination of original building plans (if available) to determine how moisture that penetrates the wall is designed to escape. Also recommend evaluation by a licensed siding contractor for remedies that might be appropriate. See photo 12 for example of contact.
- B. The west garage door is damaged or warped. Recommend repair as appropriate. See photo 13 for detail.

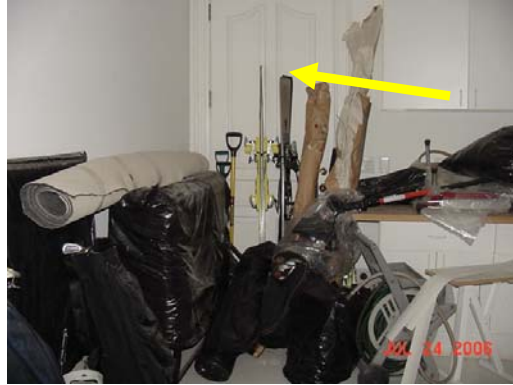
Photo #19

- C. There is moisture damaged wood at several of the exit door frames and several of the doors exhibit moisture damage at the glue joints. Recommend replacement of affected components. See photos 14 through 17 for examples.
- D. The column on the covered ramada at the east side of the pool has damage to the southwest pillar. Recommend evaluation and repair by a licensed siding contractor. Damage might be due to a leak associated with the water feature for the pool. See photo 18 for detail.
- E. The service door from the garage to the exterior could not be tested for function due to stored items against the door. Recommend testing door once items are removed. See photo 19 for detail.

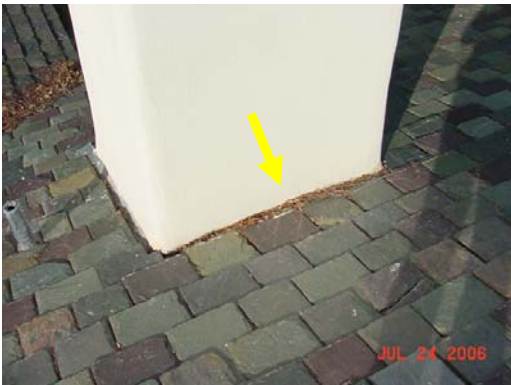
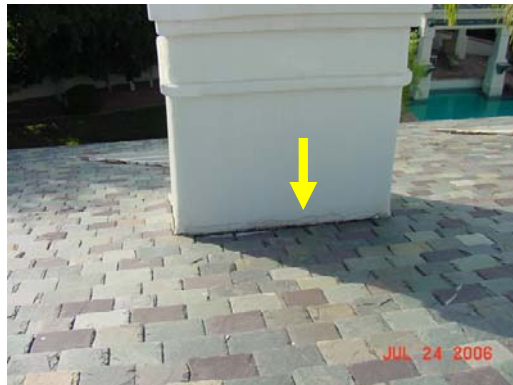
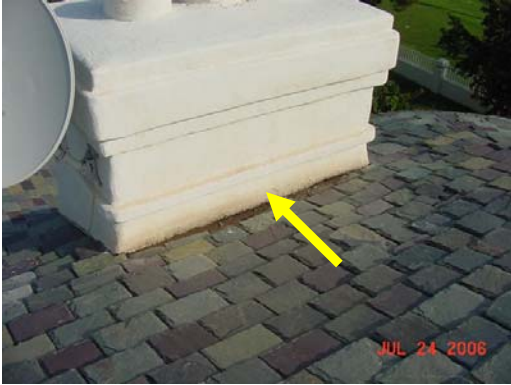
- A. There is no saddle flashing (cricket) on any of the fireplace chimneys. Crickets are required when the width of the chimney exceeds 30-inches. Recommend installation of proper crickets by a licensed roofing contractor. Also recommend through inspection of chimney flashing as damage was detected in ceilings below some of the fireplaces. See photos 20 through 22 for detail.

All the chimneys are more than 30 inches wide and do not have crickets as required. This condition traps debris and contributes to roof leakage. Recommend repair as appropriate.

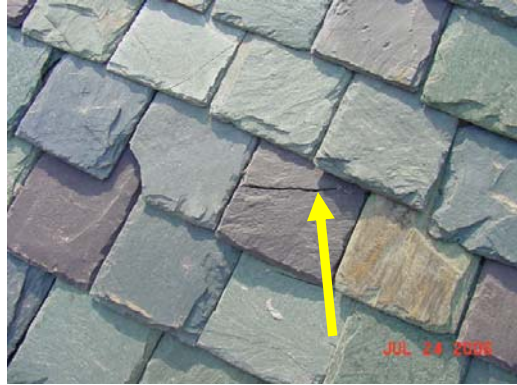
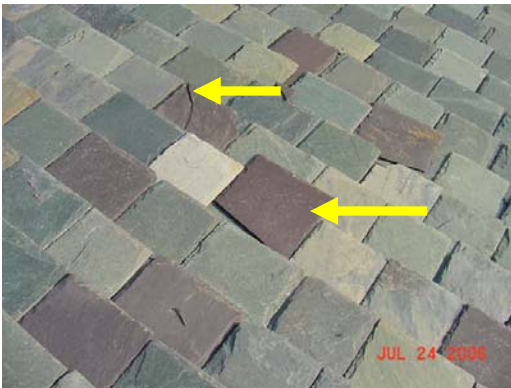
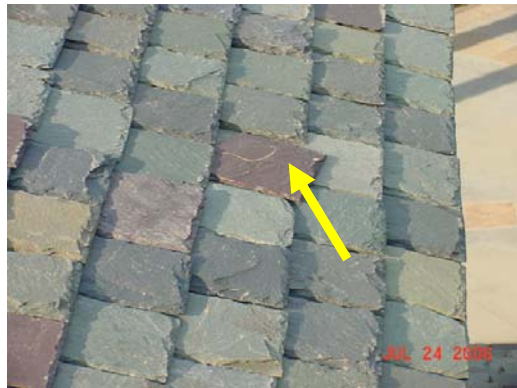
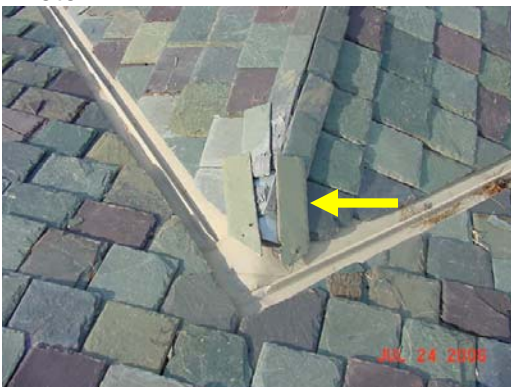
- B. There are numerous slipped or broken slate tiles on the roof. Recommend repair as appropriate by a licensed roofing contractor. See photos 23 through 26 for examples.

Some of the tiles on the roof are broken or missing. Recommend repair by a licensed roofing contractor as appropriate.

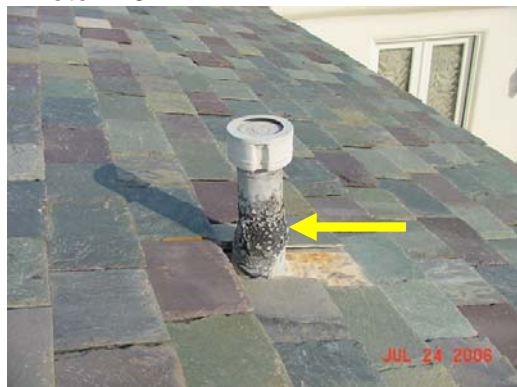
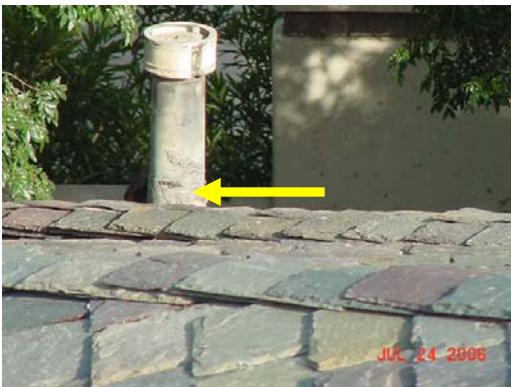
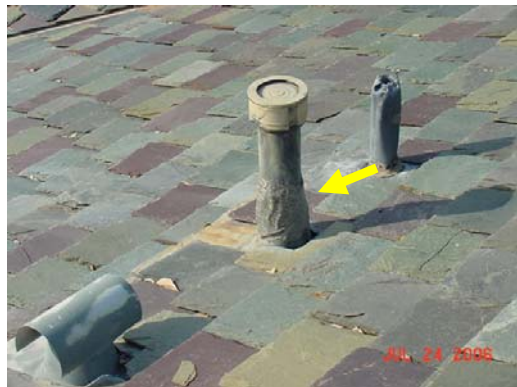
- C. There are three gas vents that exit through the roof. None have required storm collars installed. Recommend installation of storm collars by a licensed plumbing contractor. See photos 27 through 29 for detail.

All three of the gas B-vent storm collars are missing. This subjects the section seam to moisture infiltration. Recommend installing proper collars.

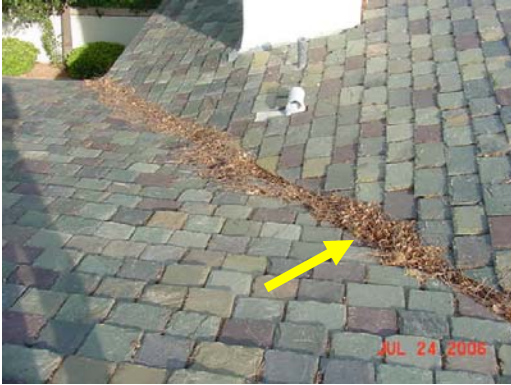
Photo #30

- D. There is tree debris clogging one of the roof valleys. Recommend cleaning to facilitate moisture runoff. See photo 30 for detail.

The metal roof valleys have a considerable debris build up from area trees. Recommend thorough cleaning of all valleys.

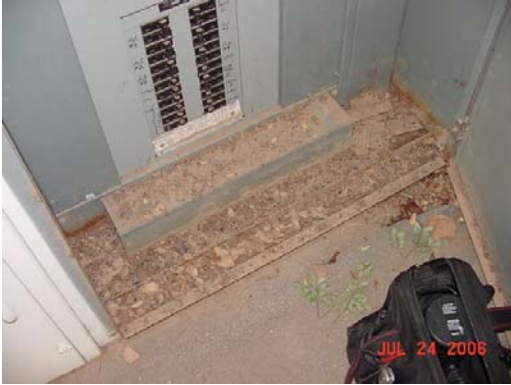
Photo #37

- A. The electrical service panel for the home is resting directly on a concrete slab. This subjects the cabinet to moisture damage. Rust and debris is evident at the bottom of the cabinet. Recommend evaluation by a licensed electrical contractor for remedies as appropriate. See photo 37 for detail.

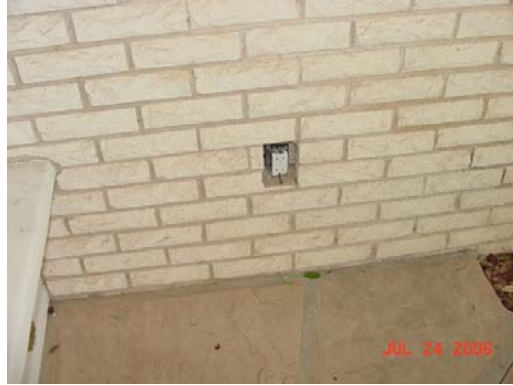
Photo #38

- B. There is a missing water proof cover on an outlet next to the exterior fireplace on the west side of the home. Recommend replacement. See photo 38 for detail.

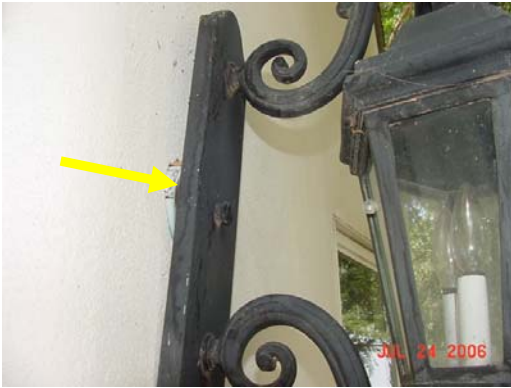
Photo #39

- C. No GFCI outlets were observed servicing the Jacuzzi tubs in the home. Recommend evaluation and repair by a licensed electrical contractor.
- D. One of the exterior light fixtures is loose in the wall by the master bath walk out door. Recommend repair as appropriate. See photo 39 for detail.

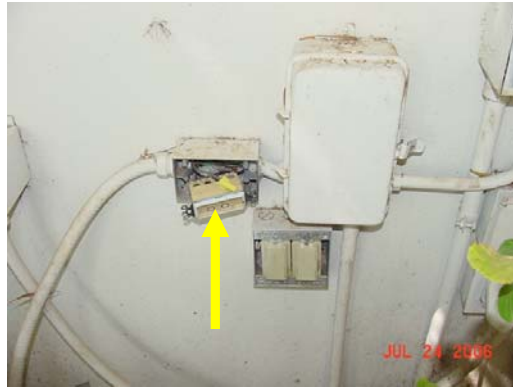
Photo #40

- E. There is an open electrical junction box adjacent to the hot tub equipment. Recommend repair as appropriate by a licensed electrical contractor. See photo 40 for detail.

There is a junction box located the hot tub equipment that is not covered and has exposed wiring. Recommend installing proper cover.

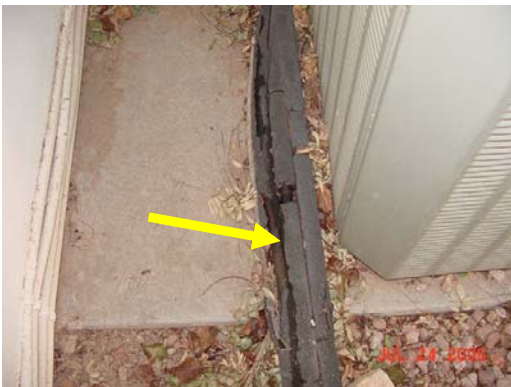
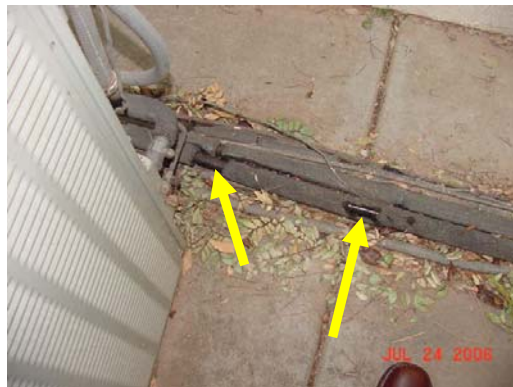
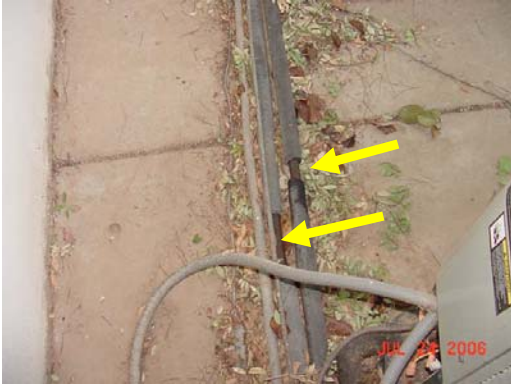
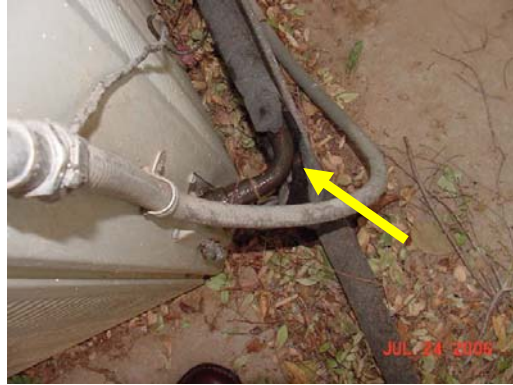
- A. None of the five heat pumps produced temperature splits that were within normal tolerances. Recommend evaluation, service and repair by a licensed HVAC contractor.
- B. Refrigeration lines for all the units are routed under ground. In the event of a line leak, this condition significantly adds to the cost of repair. Information is for disclosure purposes only.
- C. The insulation on the suction lines to the units is damaged and or deteriorated. Recommend replacement of suction line insulation. See photos 41 through 44 for detail.

The insulation on the suction lines for four of the five units is damaged or missing. Recommend repair as appropriate.

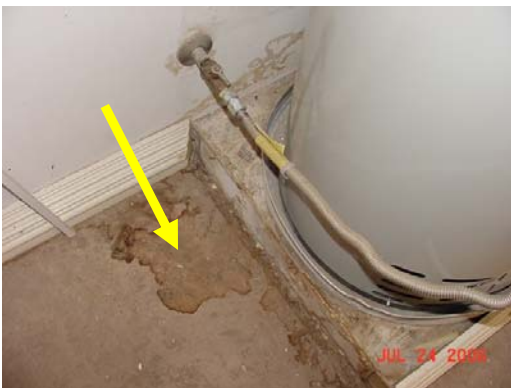
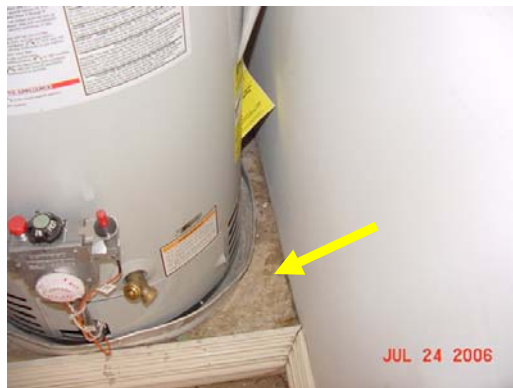
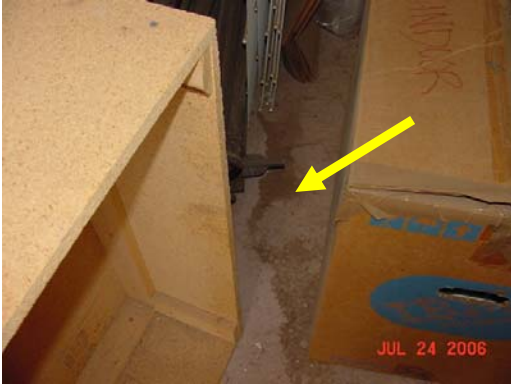
- A. There is moisture stain on the flooring adjacent to the water heater on the upper floor. Recommend destructive testing by a mold remediation company and remedy as appropriate. See photos 45 through 47 for detail.

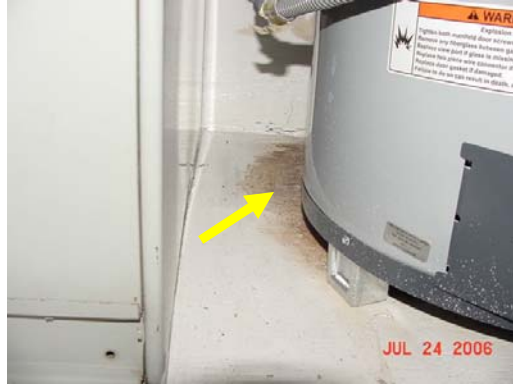
Photo #48

- B. There is a moisture stain on the flooring next to the garage water heater. Recommend destructive testing by a mold remediation company and remedy as appropriate. See photo 48 for detail.

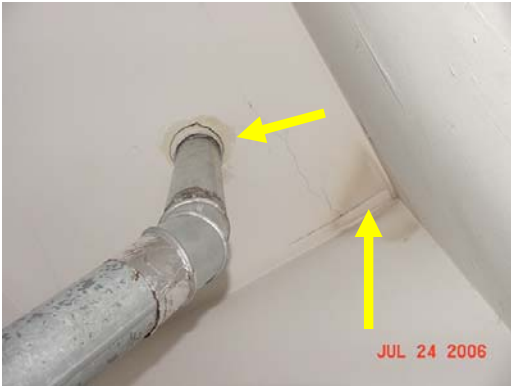
Photo #49

- G. The closet door in the laundry scrapes on the floor. Recommend repair as appropriate.
- H. There is moisture damage to the ceiling in the utility closet in the garage. Recommend destructive testing by a mold remediation company and remedy as appropriate. See photo 49 for detail.
