# Home Inspection Report

Address Redacted

Report Prepared By:  
James H. Duke

July 24, 2006

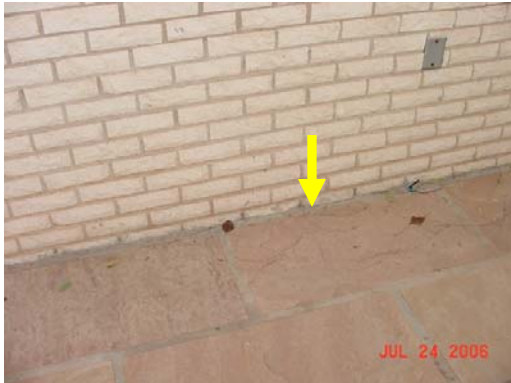
Photo #12

- A. There is no visible weep screed on the exterior of the home. The stucco and or the brick veneer is in contact with earth. Moisture damage in photos 4 and 5 might be the result of this condition. Recommend examination of original building plans (if available) to determine how moisture that penetrates the wall is designed to escape. Also recommend evaluation by a licensed siding contractor for remedies that might be appropriate. See photo 12 for example of contact.
- B. The west garage door is damaged or warped. Recommend repair as appropriate. See photo 13 for detail.

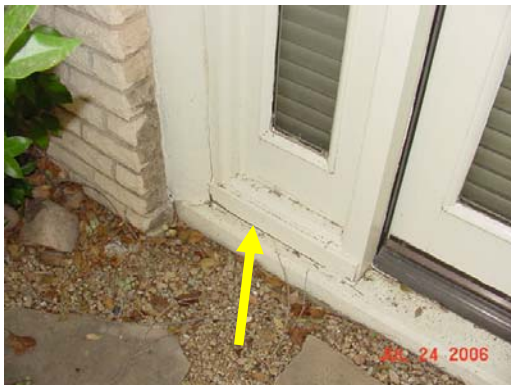
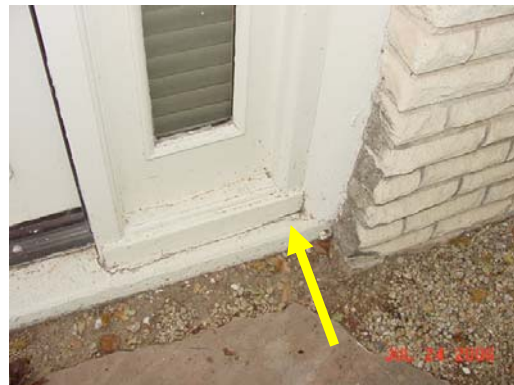
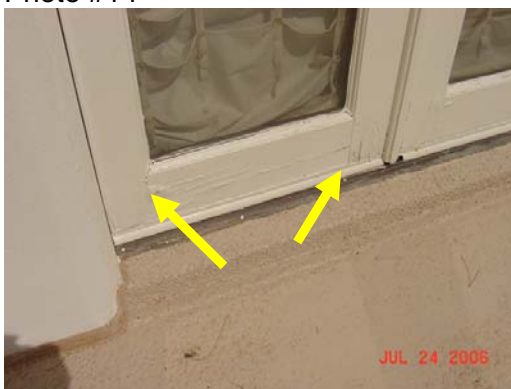
- C. There is moisture damaged wood at several of the exit door frames and several of the doors exhibit moisture damage at the glue joints. Recommend replacement of affected components. See photos 14 through 17 for examples.
- D. The column on the covered ramada at the east side of the pool has damage to the southwest pillar. Recommend evaluation and repair by a licensed siding contractor. Damage might be due to a leak associated with the water feature for the pool. See photo 18 for detail.
- E. The service door from the garage to the exterior could not be tested for function due to stored items against the door. Recommend testing door once items are removed. See photo 19 for detail.

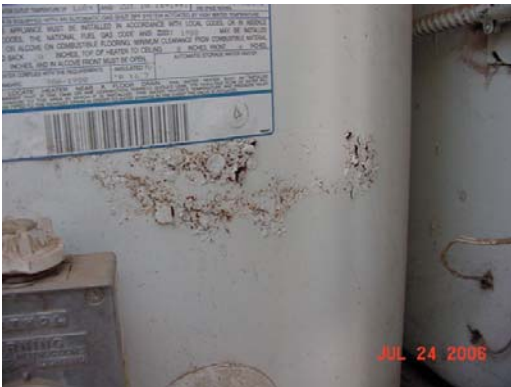
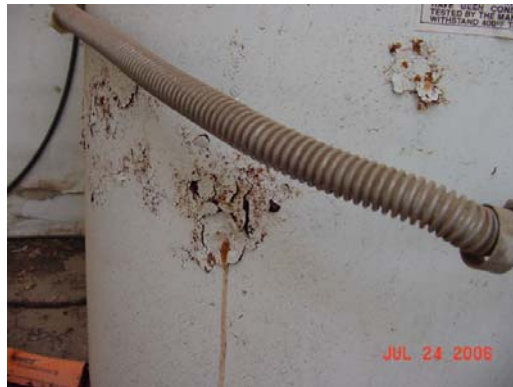
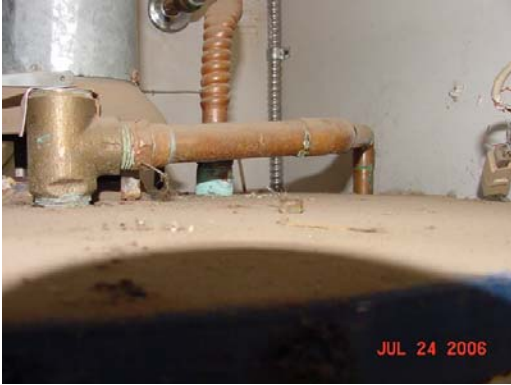
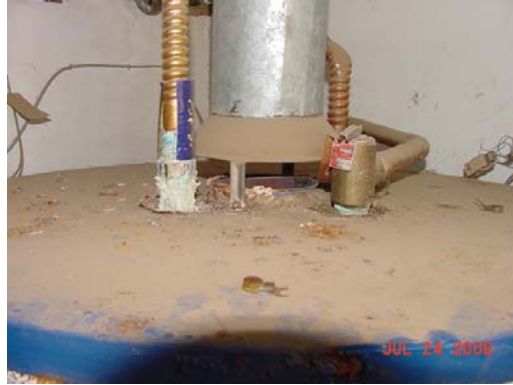
- A. The water heater in the west exterior utility closet appears to be at the end of its service life. Additionally, the temperature pressure relief line is running uphill and the water supply line is corroded and leaking. Recommend replacement. See photos 31 through 34 for detail.
- B. One exterior cleanout was examined and it was determined that the screw that secures the decorative cover is too long and penetrates completely through the cap. This condition allows effluent to escape through the cap and infiltrate into the framing for the walls. Recommend evaluation and repair of all similarly configured caps located inside and outside the home. See photos 35 and 36 for detail.
- C. The enclosures for the gas water heaters in the home do not have proper ventilation. (upper vents are missing) Recommend repair as appropriate by a licensed plumbing contractor.
